# ENDURAFLOOD TECHNOLOGIES, LLC. FIRE TEST REPORT

NFPA 286 TESTING ON ENDURAFLOOD FLOODPROOF DRYWALL SYSTEM WHEN INSTALLED TO AN INTERIOR WALL.

P5021.01-121-24 r0

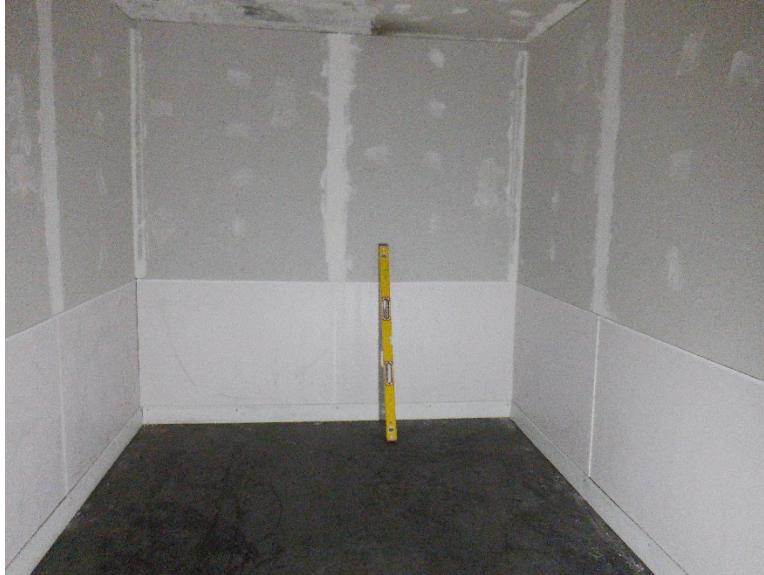
**Photo No. 1**  
**Completed Room**

An additional layer of 5/8 in. gypsum board measuring 59 ½ in. was applied to the interior gypsum clad walls from the ceiling down. All joints and fastener heads were finished in the same manner as stated above. EnduraFlood FloodProof Drywall system was then installed below the second layer of gypsum according to the manufacturers installation instructions, which can be found at [www.enduraflood.com](http://www.enduraflood.com).

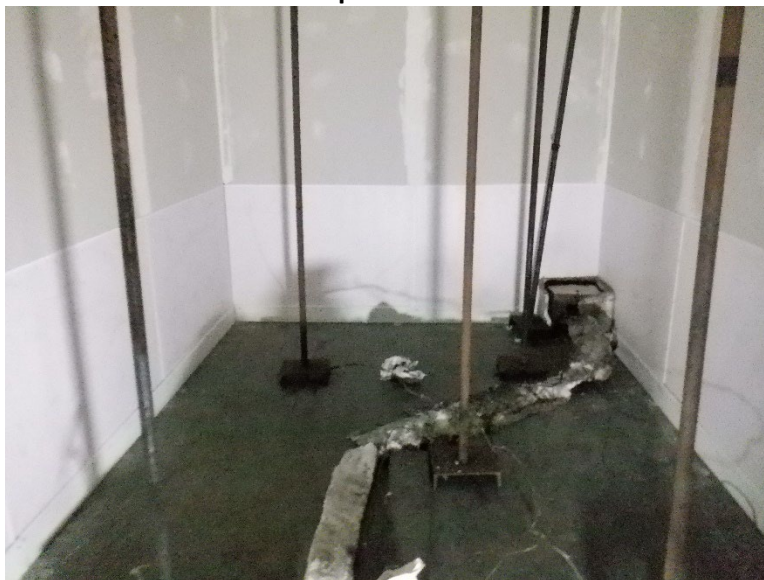
**Photo No. 2**  
**Complete Room Pre-test**

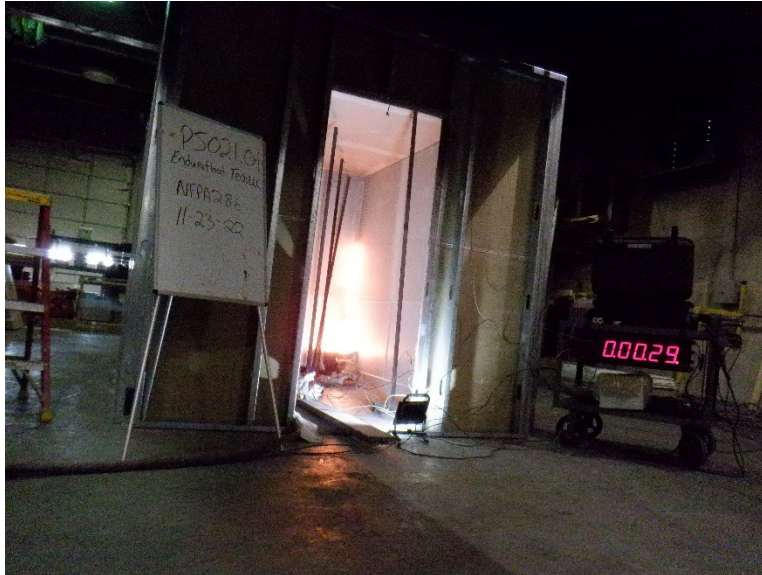
**Photo No. 3**  
**Start of Test**

TEST OBSERVATIONS	
Time (Min:Sec)	Observations
00:00	Ignition of the burner. Heat output set at 40kW
00:12	Ignition of the product at the corner with the burner.

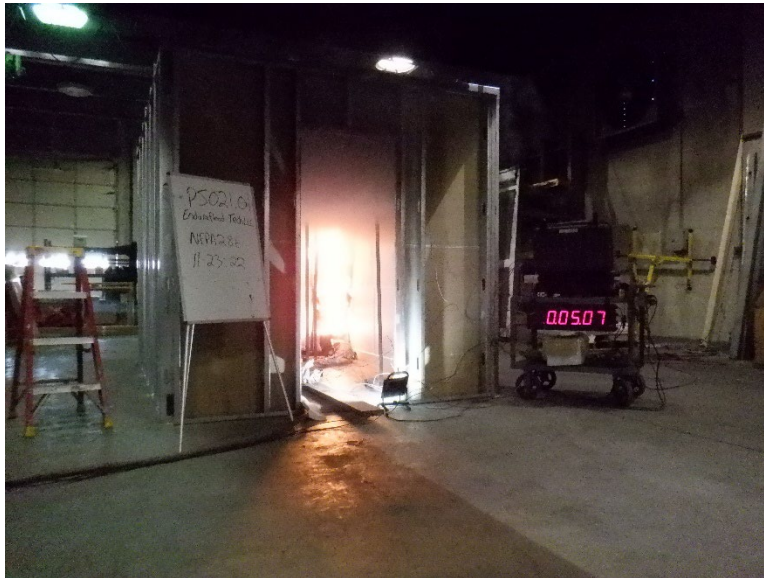
**Photo No. 5**  
**Initiation of 160 kW**

05:00	Heat output of the burner increased to 160 kW.
05:36	Vertical flame propagation to 4 feet in the corner with the burner.
08:17	Smoke turning light grey in color.

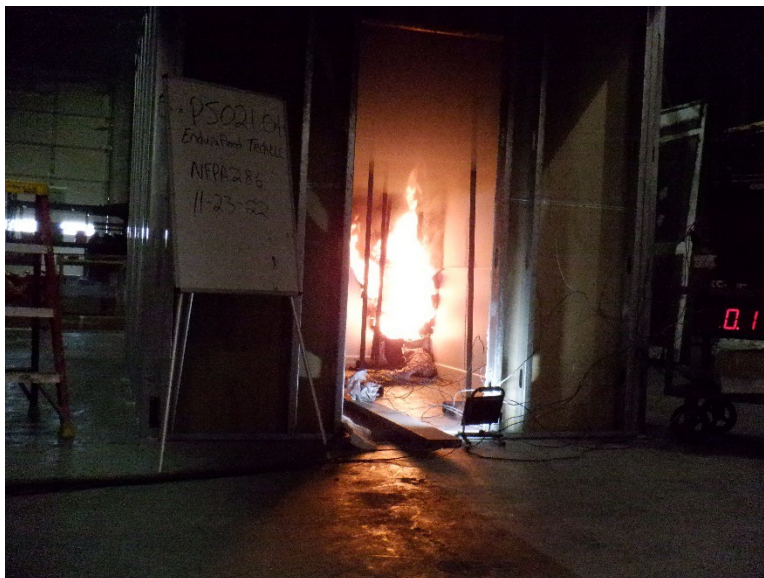
**Photo No. 6**  
**Horizontal Flame Propagation to 2 feet on Back Wall**

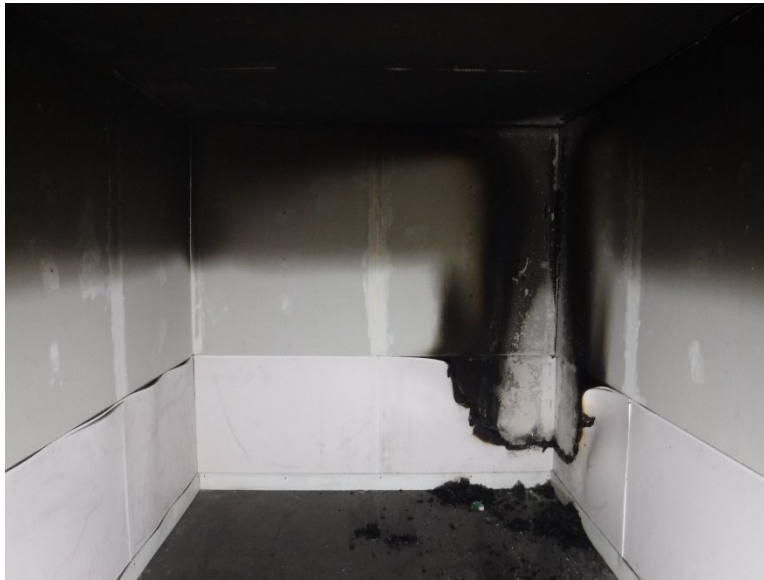
**Photo No. 7**  
**Post Test**

15:00	Gas to the burner is shut off. Burner Extinguished; test concluded
16:47	All flaming on the product self-extinguished.

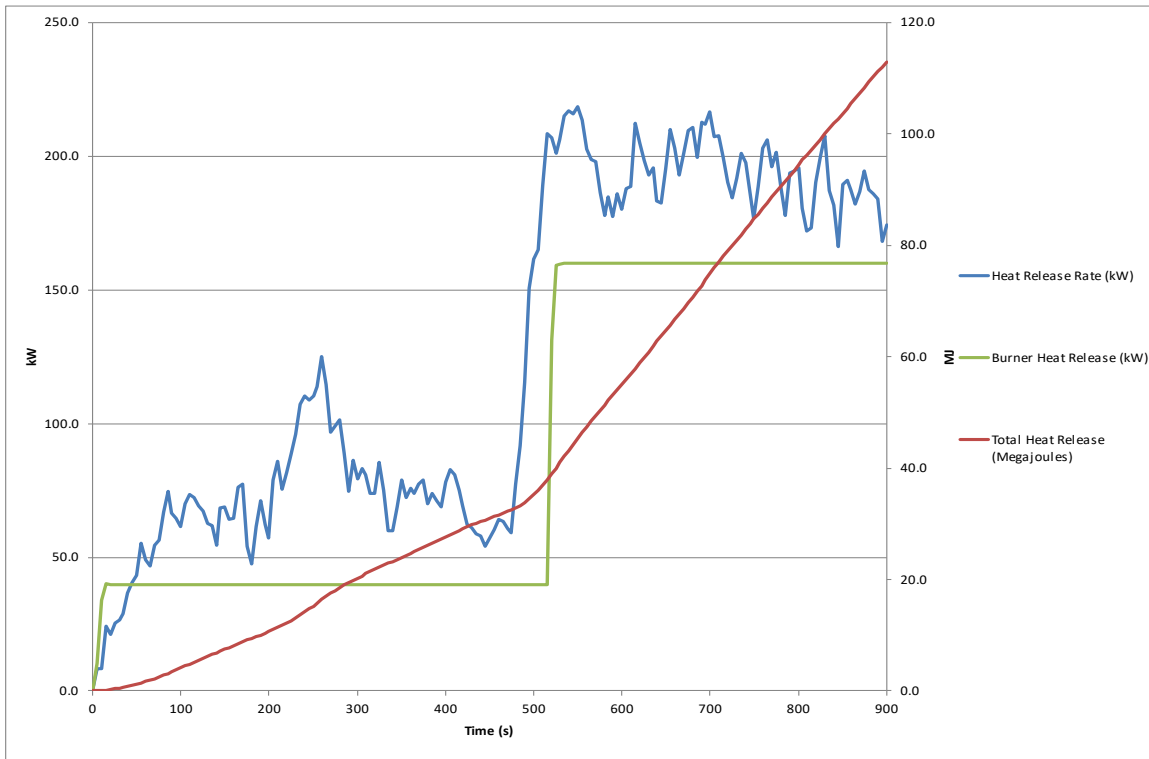
**Graph No. 2**  
**Heat Release Data**

2015 IBC SECTION 803.1.2.1 & NFPA 286 ANNEX C PERFORMANCE CRITERIA	TEST OBSERVATIONS	PASS/FAIL
During 40 kW exposure, flames should not spread to the ceiling.	Flames did not spread to the ceiling during the 40kW exposure.	<b>PASS</b>
During the 160 kW exposure, the interior finish should not spread to the outer extremity of the sample on any wall or ceiling	Flames propagation to the outer extremities did not occur during the 160kW exposure.	<b>PASS</b>
<p>During the 160 kW exposure, the interior finish should not flashover as defined by NFPA 286.</p> <ul style="list-style-type: none"> <li>•Peak Heat Release &gt; 1 MW</li> <li>•Floor Heat Flux &gt; 20 kW/m<sup>2</sup></li> <li>•Average Upper Layer Temperature &gt; 1,112°F</li> <li>•Flames exiting doorway</li> <li>•Auto ignition of Paper Target</li> </ul> <p>Flashover is considered to have occurred when any two of the above criteria were met during the test.</p>	<ul style="list-style-type: none"> <li>•Peak Heat Release = 218.4 kW</li> <li>•Max Floor Heat Flux = 2.25 kW/m<sup>2</sup></li> <li>•Max Average Upper Layer Temperature = 533°F</li> <li>•No Flames exited doorway</li> <li>•The flashover indicators did not ignite.</li> </ul>	<b>PASS</b>

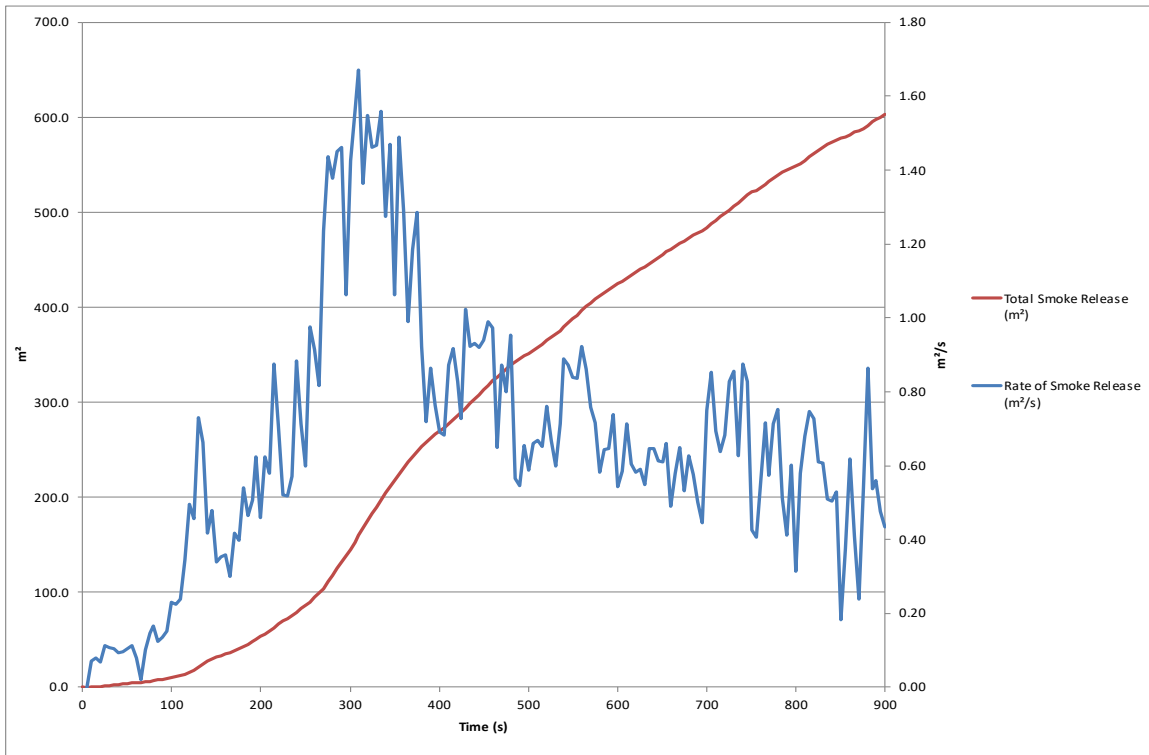
**Graph No. 3**  
**Smoke Release Data**
